Manhole Inspection Summary

Manhole # S35WW_016MH

Insp Date: **1/8/07 12:15 PM**

Location Address: **201 30TH ST**

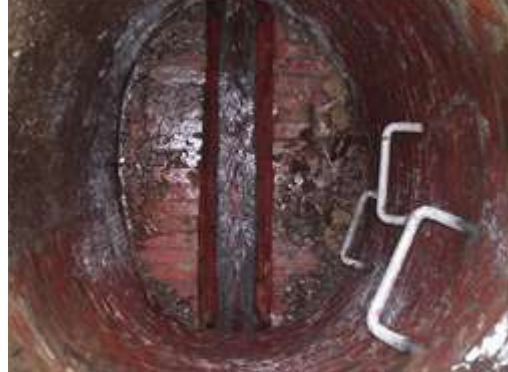
Top View

Bench ☒ Exists Material: **Brick** ☐ Parged ☒ **Debris** (not Condition related)

Surcharge ☒ **Evidence Of Surcharge** Depth: **1** (ft.) ☐ Active Surcharge Present

Evidence of surcharge - Bench debris.

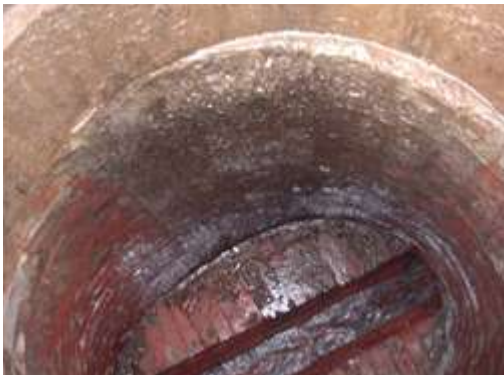
Defect

Frame Offset: **1** (in.) Condition: ☐ Sound ☐ Cracked ☒ **Leaks**

Condition: ☐ Sound ☐ Cracked ☐ Root Intrusion ☐ Loose Brick ☒ **Deteriorated**

Infiltration: ☐ None ☒ **Joint** ☐ Cracks ☐ Mortar ☐ Roots ☒ **Wall**

Infiltration: ☐ None ☐ Joint ☐ Cracks ☐ Mortar ☐ Roots ☒ **Wall**

Frame leaks. Frame offset. Adjustment deterioration and infiltration. Corbel infiltration - other side.

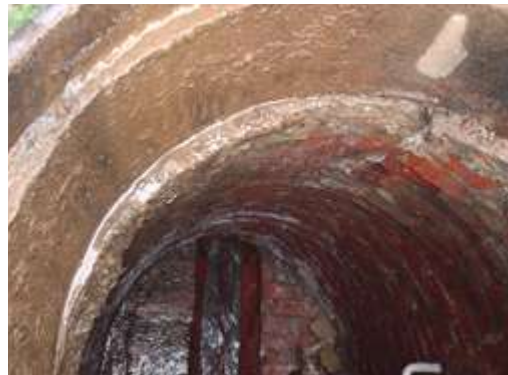
Defect

Frame leaks. Frame offset. Adjustment deterioration and infiltration. Corbel infiltration.

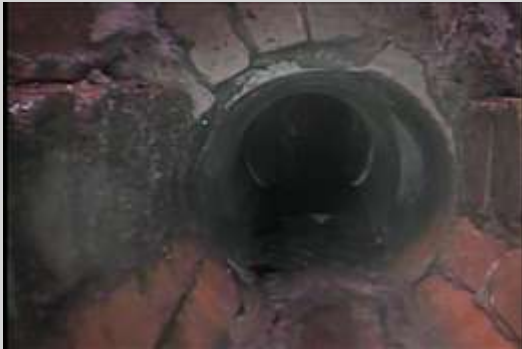
10 in. Circular Gravity Sewer Pipe Out @ 12 O'Clock

Infiltration: **Evidence** Pipe Seal Cond: **Unknown**

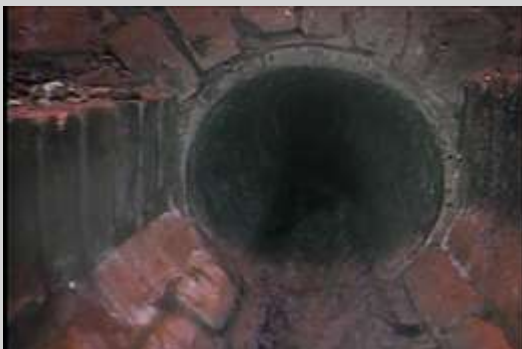
10 in. Circular Gravity Sewer Pipe In @ 6 O'Clock

Infiltration: **None** Pipe Seal Cond: **Unknown**
